UltraCrete repairs troublesome chamber on busy London road

CONTRACTOR: CENTERCOMMS LTD

SITE: CENTRAL LONDON

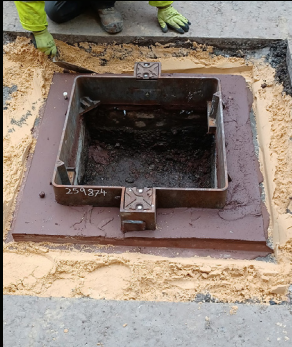
As well as a tight turnaround, upon arrival it became clear very quickly that chamber was damaged and the brickwork needed to be excavated.

To begin, the damaged brickwork was removed and timber shuttering installed using UltraCrete QC10 F. This fast, strong and easy to use flowable concrete provides an extremely robust repair in just 20 minutes.

Using the SG Pam Install Plus frame installation system, Centercomms Ltd carefully placed the frame and used a string line to ensure it was level with the existing road surface.

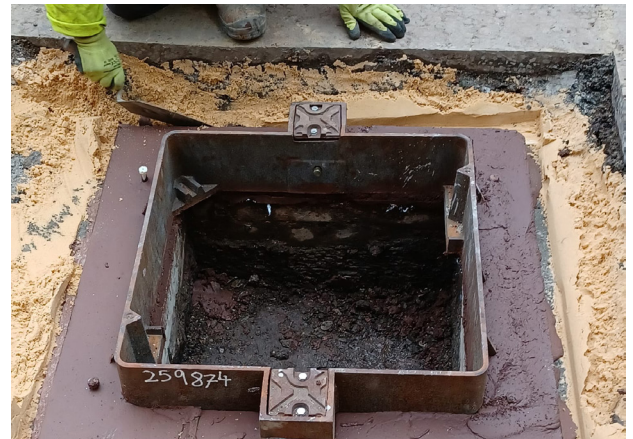
Once in position, Envirobed® CD534 Red high performance bedding mortar was applied to the inner face and chamber top and the timber shuttering was then placed 50mm beyond the flange.

After Envirobed® CD534 Red had fully cured, Envirobed® CD534 Flowable Red was mixed and poured to fully bed and encapsulate the frame to a minimum depth of 35mm. To complete the installation, operatives returned the lid into position, applied SCJ seal and tack coat spray to the vertical edges of the existing road surface and frame ahead of the asphalt reinstatement.
