UltraCrete prevents accident in Carmarthen

UltraCrete's market-leading Flowable Installation System has been used to repair a faulty carriageway frame and cover on the B4299 in Carmarthen.

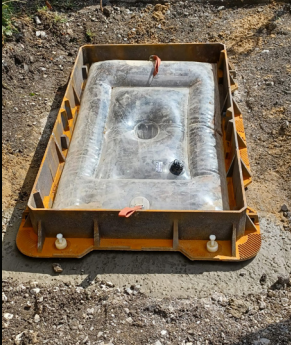
A large section of a rural road in Carmarthen was severely damaged. The area in question is located at the bottom of a hill and over time, the relentless force in which cars and tractors have hit the road surface has severely deformed the surface.

The consequence of this damage also caused structural damage to a nearby carriageway frame and cover.

HT Installations Limited utilised UltraCrete QC10 F flowable fibre modified concrete to repair the brickwork chamber and their Envirobred® Flowable Installation System to install the replacement CW2 frame and cover – a process used by Openreach for all their carriageway repairs.

To begin, the entire area was excavated and spoil removed. The contractors assessed the chamber and utilised the Mortar Buoy® installation aid within the chamber as an alternative to formwork/shuttering. They proceeded to mix and pour UltraCrete QC10 F, rapid set flowable concrete, to repair the damaged concrete chamber.
