Dewsbury Town Hall

CONTRACTOR: OPUS TILE RESTORATION

MATERIALS USED: PROFLEX SPES, PROGROUT FLEXIBLE

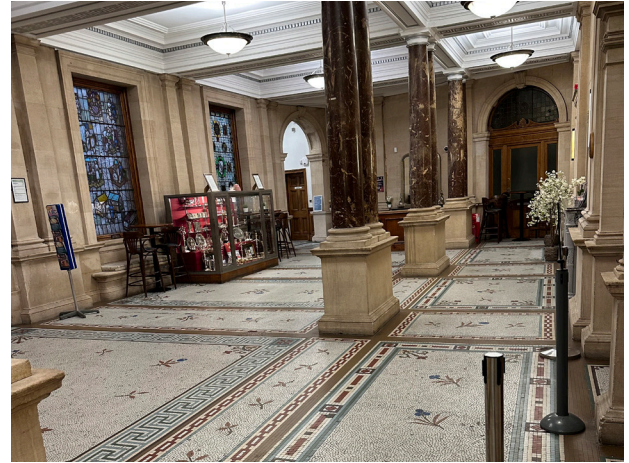
Phase 1 of the works successfully reinstated the appearance and performance of the mosaic floors, ensuring they remain structurally sound and visually faithful to the original Victorian craftsmanship. The restored areas now once again contribute to the architectural splendour of Dewsbury Town Hall.
