UltraCrete and Telent join forces to tackle failed ironwork

CONTRACTOR: TELENT

SITE: SUTTON COLDFIELD

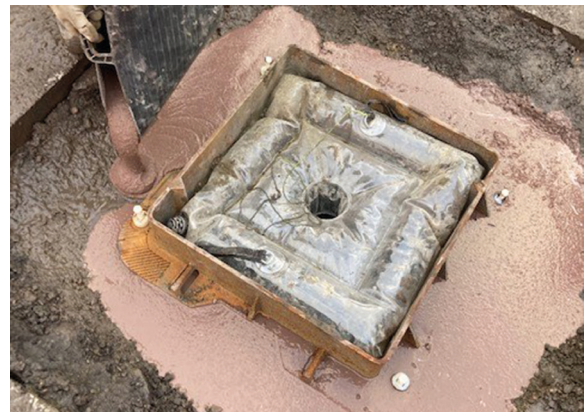
Specially formulated for utility reinstatements, Envirobed® CD534

Flowable high performance bedding mortar is BT LN550 and LN320 compliant and offers superior compressive, tensile and flexural strengths in just 3 hours.

The new CW1 cover was installed using the Install Plus method. To begin, Mortar Buoy® was inflated in the existing chamber to prevent debris falling into the cavity and causing potential damage to the network. Once inflated, the team were able to use Mortar Buoy® as internal shuttering and repair the damaged chamber using QC10 F rapid strength flowable concrete.

To complete the installation, Mortar Buoy® was used as a dam and Envirobed® CD534 Flowable was poured around the edges of a chamber for a permanent installation.
