# UltraCrete improving road safety near Shrewsbury

UltraCrete has joined forces with Highway Workforce to repair and replace a failed carriageway frame and cover on a busy road near Shrewsbury.

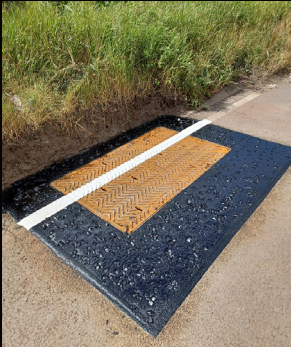
What's more, the carriageway frame was partially buried by the grass verge and over the years, rain and washout had filled the lifting holes and chamber with dirt and silt, adding another element to the repair.

To assess the full extent of the damage, Highway Workforce began by cutting away the grass verge to reveal the full frame and cover. The silt was then removed to reveal the brickwork chamber.

A standard hammer test was carried out to check for brickwork damage with Highway Workforce quickly establishing that the substrate was sound and the frame and cover just needed to be replaced.

The area was marked up and broken out in line with the SROH, the old frame and cover removed, and the area swept clean of any spoil. Once the frame and cover had been lowered into position, the frame

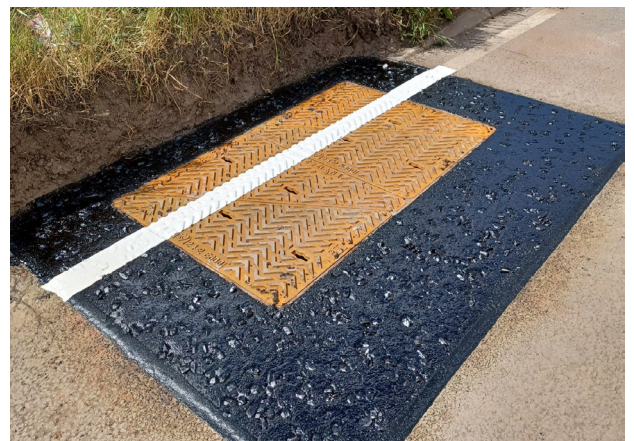
was levelled with the existing road surface using a string line and Install Plus levelling feet with external shuttering placed to retain the flowable mortar 50mm beyond the flange edge. To further reinforce the shuttering and prevent any seepage, a sand bund was applied behind the shuttering. Once in place, a carriageway 2 Mortar Buoy® was inflated to seal the chamber top and frame ahead of the mortar pour.

UltraCrete Envirobed® CD534 Flowable Red was mixed and poured to fully encapsulate the frame flange. Just 12 minutes after the application of Envirobed®, the Mortar Buoy® and shuttering was removed, and the area prepared to receive Enviro Mastic® rubber modified mastic asphalt.

UltraCrete Enviro Mastic® was applied by the contractors in standard layers and stone chippings added to the final wearing course. To complete the project, the reinstatement was overbanded to seal the old and new surfaces and road markings replaced using Instaline in white.
